North Creek Forest Stewardship Plan

University of Washington-Restoration Ecology Network
Capstone Course 2018-2019

Prepared for
Friends of North Creek Forest and the City of Bothell

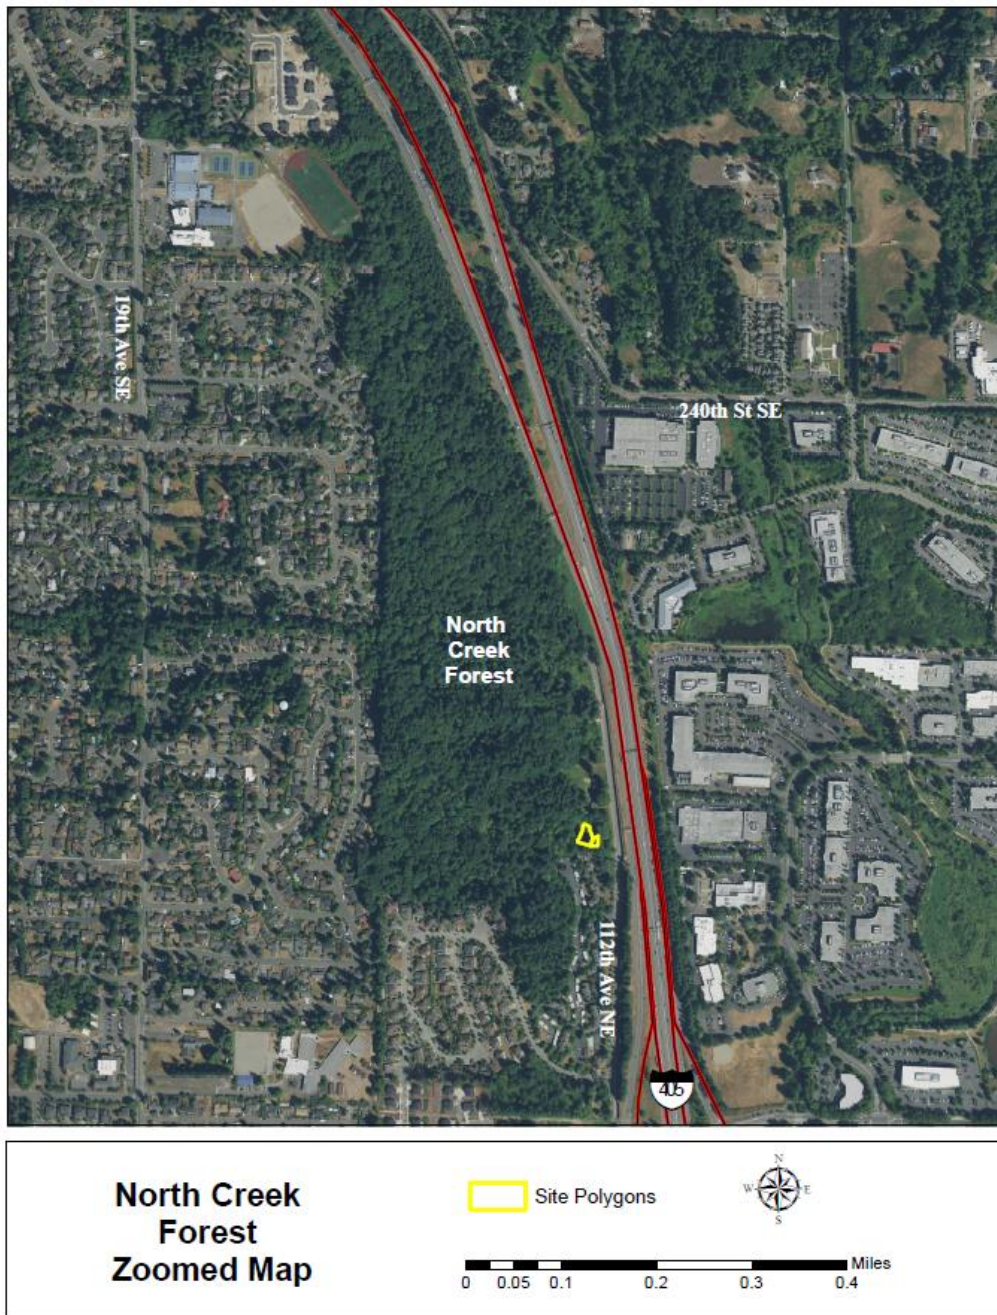
Figure 2. North Creek Forest restoration project site location

The overall restoration site is within the Puget Sound region near the north end of Lake Washington by the Sammamish River. It is located in the City of Bothell just north of University of Washington - Bothell Campus, and west of the North Creek (Figure 1). The restoration site is at the south end of North Creek Forest right next to the park entrance sign along 112th avenue (Figure 2).

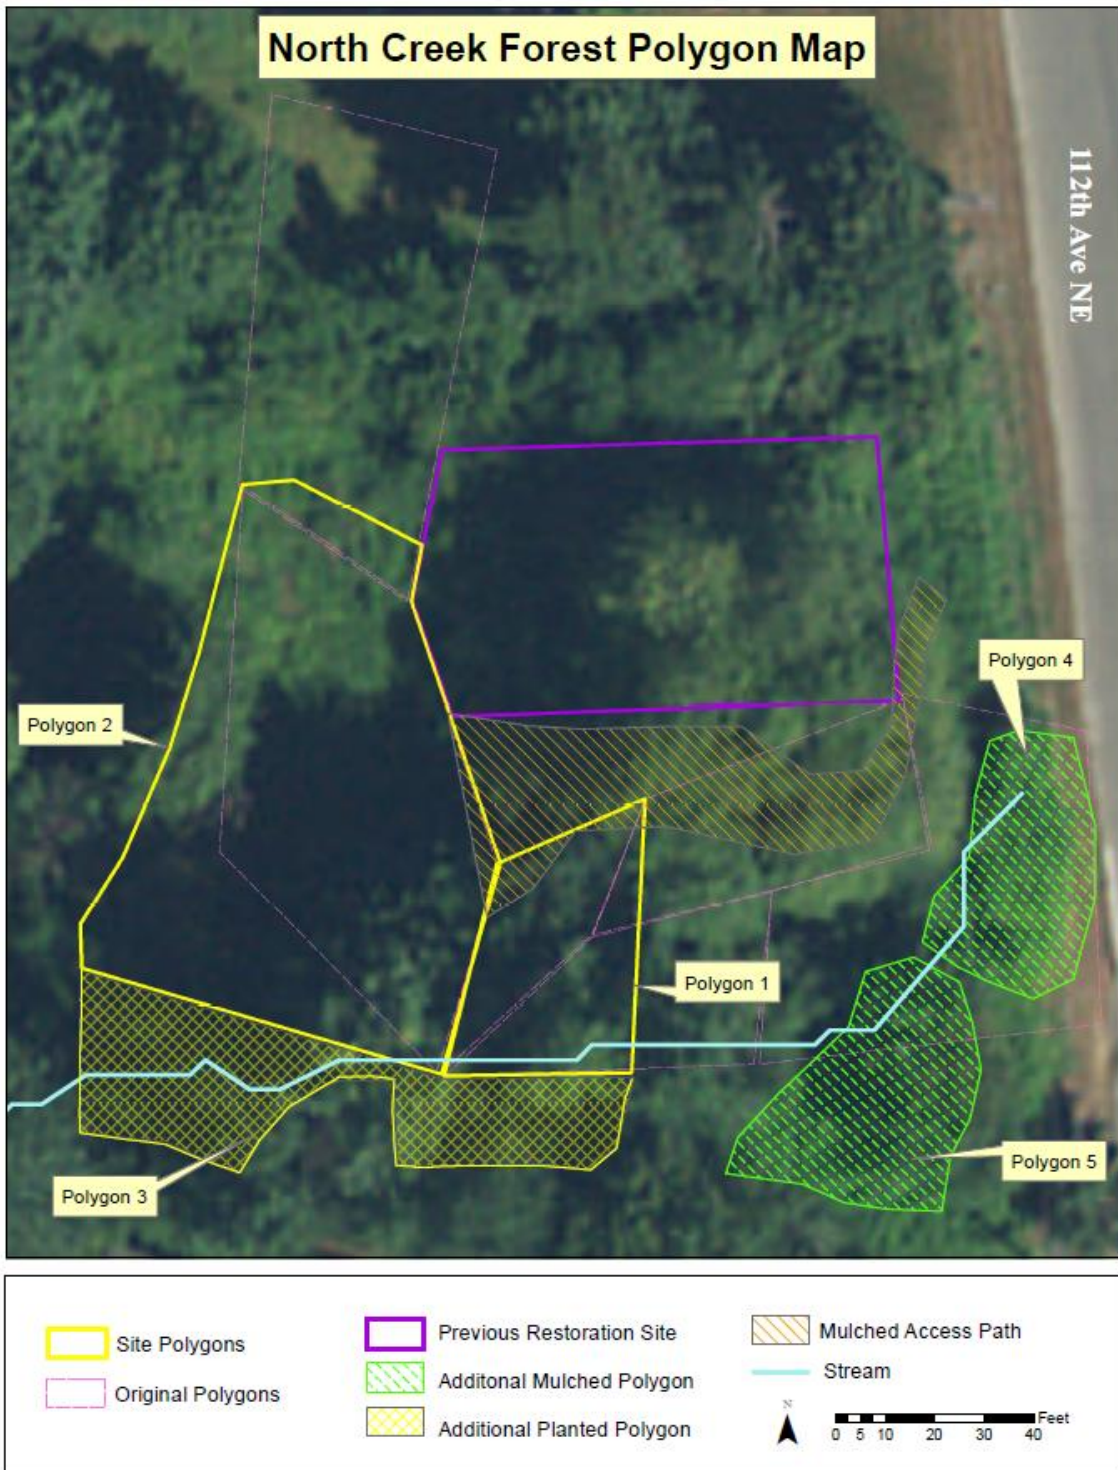
Figure 3. North Creek Forest polygon map

The mulched access path to the previous restoration effort and our site was re-mulched twice throughout the past year. Originally, our site included six polygons but were renamed to better ensure a high planting density. Polygon 1 (previously named updated polygon 4) consisted of moist and shady conditions, considerably different from Polygon 2 (previously named updated polygon 6), which consisted of dry, sunny and upland conditions.

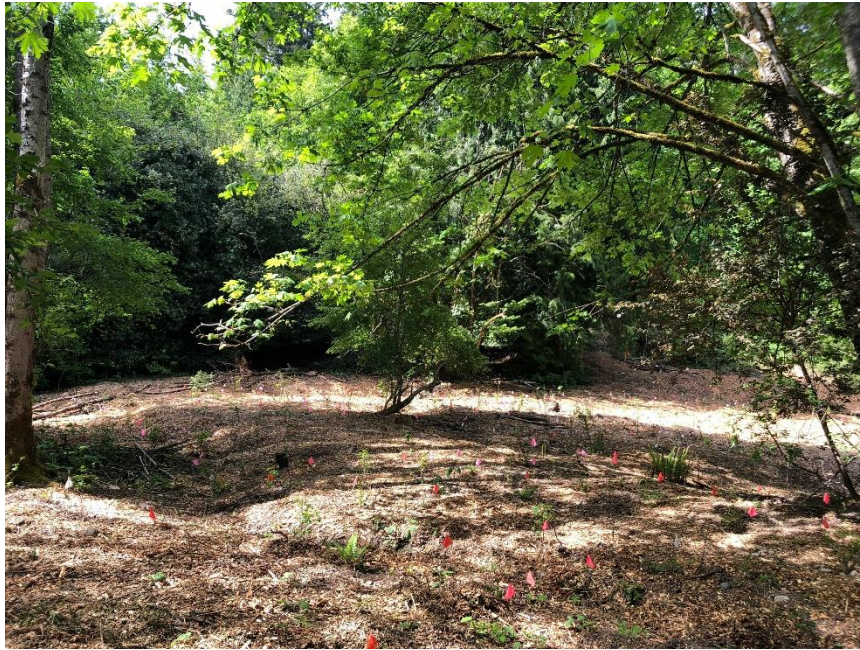
Photo point A

Polygon 1 has two photo points. One photo point (A) is located south of the bigleaf maple, and will be marked with a propped-up birdhouse on top of a post and the letter A on it (Figure 6; Photo point A). The second photo point (B) is located west of the bigleaf maple within polygon 2, and will be marked with a propped-up birdhouse on top of a post and the letter B on it (Figure 6; Photo point B) These two photo points will capture two opposing views of polygon 1, capturing all of the plant species we planted.
